JOWETT JUPITER ENGINE ASSEMBLY

Engine Number E3 SCL 987

Recorded by Philip Dingle

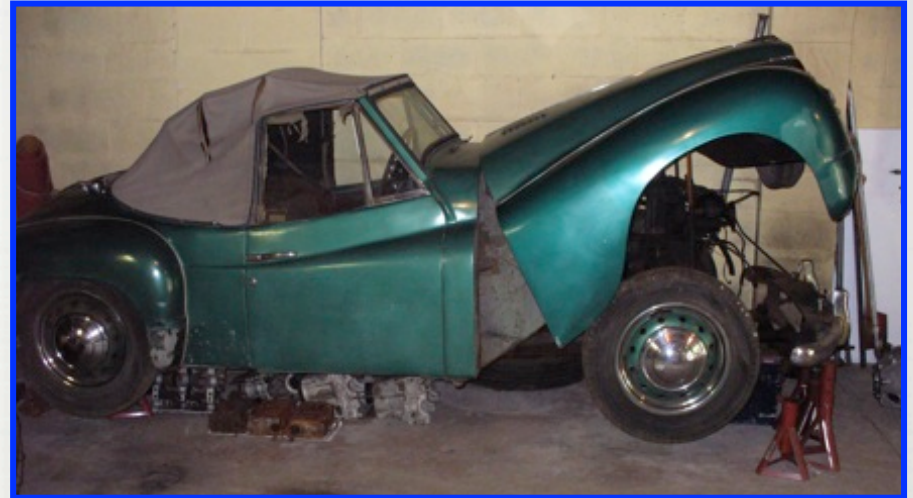
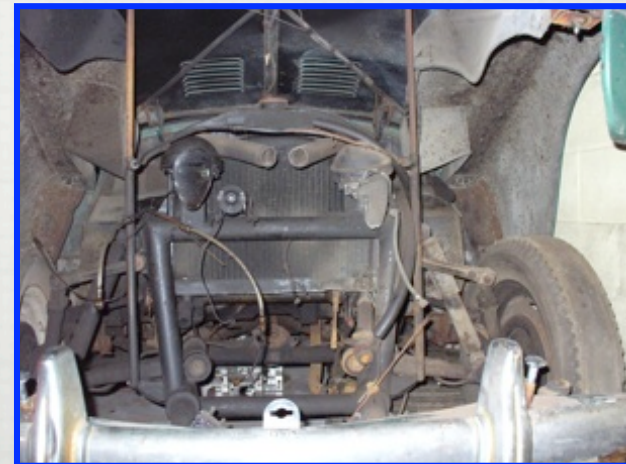
ENGINE NO. E3 SCL 987

- ❑ This engine belongs to Car No. E3 SCL 987 owned by the late David Cleavinger of Livonia, Michigan USA.
- ❑ The crankcase-half numbers 91166/25884 do not match. This appears to be a replacement engine, probably provided by Jowett Engineering Ltd.
- ❑ In the photo here, another crankcase with the same number (possibly the original pair) can be seen under the car.

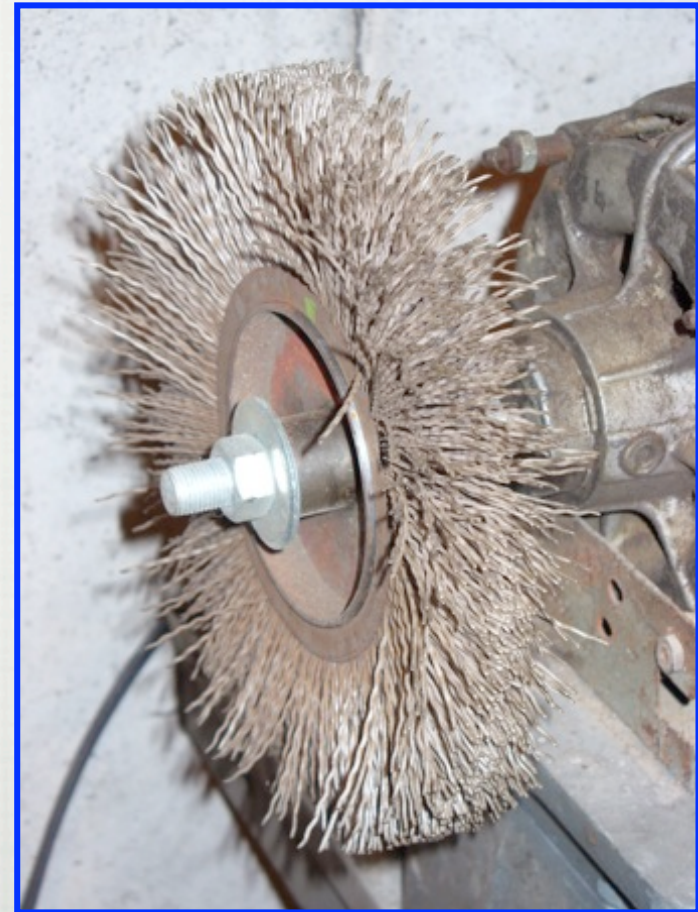
COMPONENT CLEAN-UP AND INSPECTION

- For component degrease and clean-up, I used Brulin 815QR which is a water-based industrial cleaning agent and this did a good job on all components.
- Brulin degreases best when heated so I found a tub large enough to take a half crankcase, and then added a 1 kW heating element.
- To make items look like new, I used a carborundum-laced nylon brush wheel (picture) mounted on an electric motor which worked well.

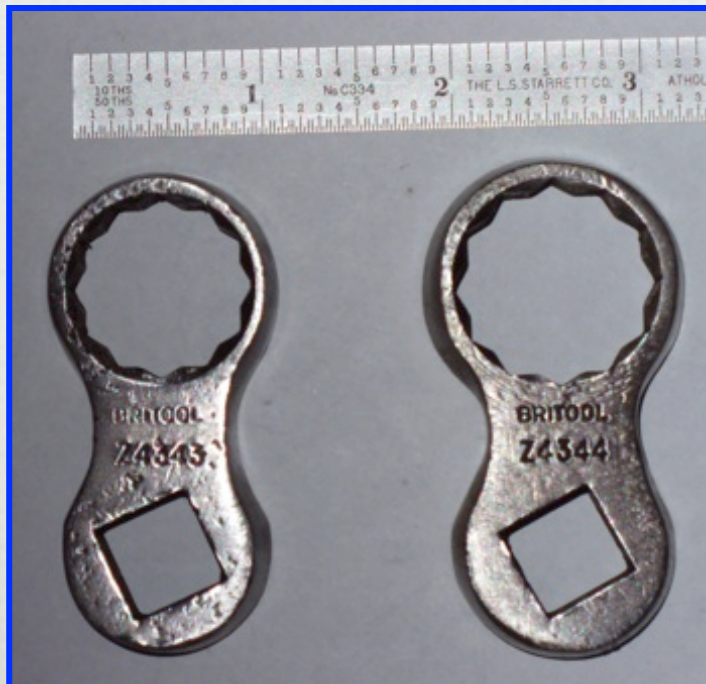
CRANKCASE THROUGH-BOLTS

- It helps, but is not essential to have the correct Jowett tools for torquing up the through-bolts.
- Torque for both bolt sizes is 75 lb/ft.

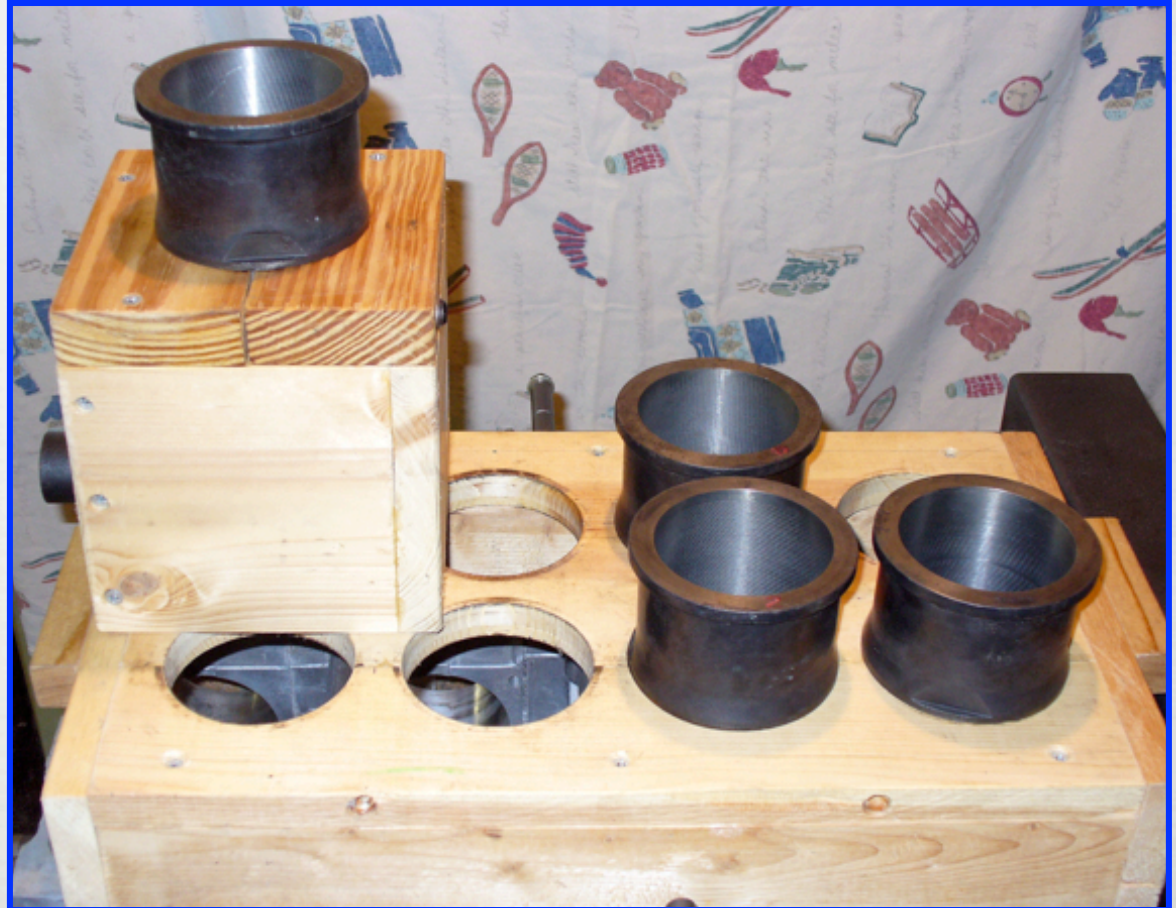
CYLINDER LINERS

- To safely transport and store the cylinder liners, I made up a wooden tray to hold them (I don't recall why I made an 8-holer crate).
- Not too many auto machine shops in the US are equipped to handle wet liners. I had to make up a box into which a liner could be clamped so the boring machine could grip it.

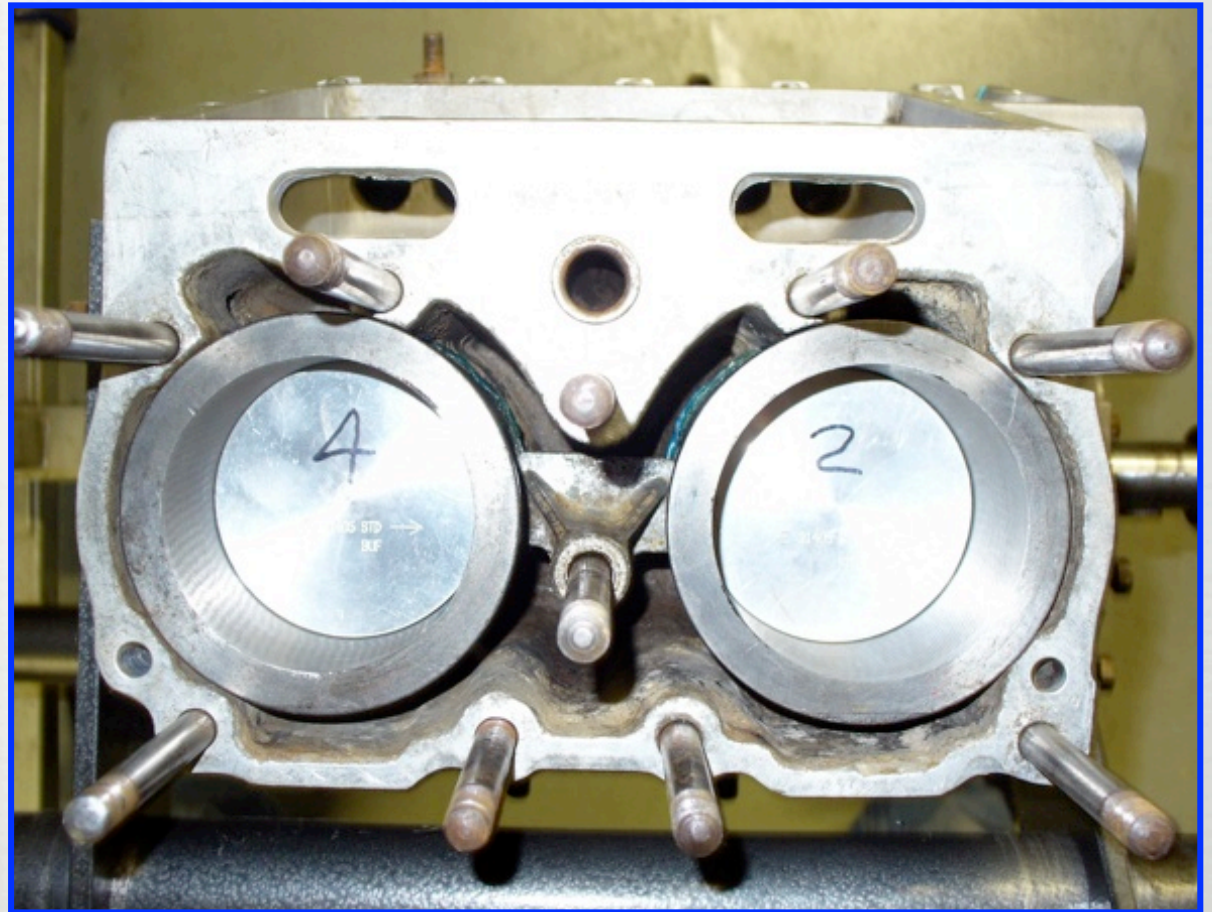
READY FOR HEAD GASKET

- With both liners and the intermediate liner locator shimmed to give the correct stand-out or protrusion from the crankcase, it is time to fit the head gasket.

Original Payen brand head gaskets are no longer available. These gaskets came from Bill Lock Spares Ltd. They were not a perfect fit, and needed some adjustment to fit over the studs.

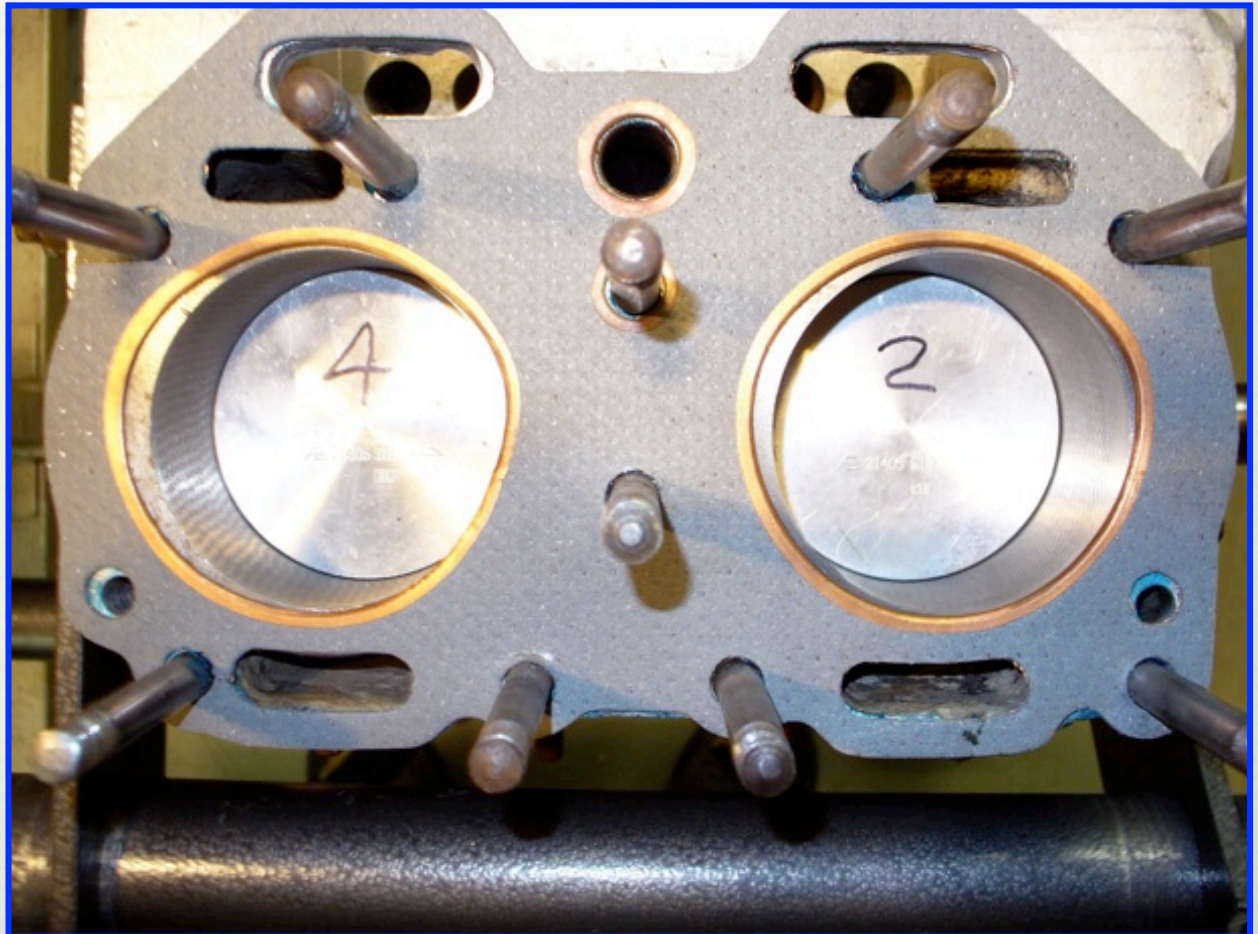
HEAD GASKET ALIGNMENT

- The registration of the windows in the gasket are not aligned with the features of the crankcase as well as I would like to see.
- The gasket underlaps the lower rim of the crankcase, which due to corrosion, is normally its weakest zone and most in need of sealing.

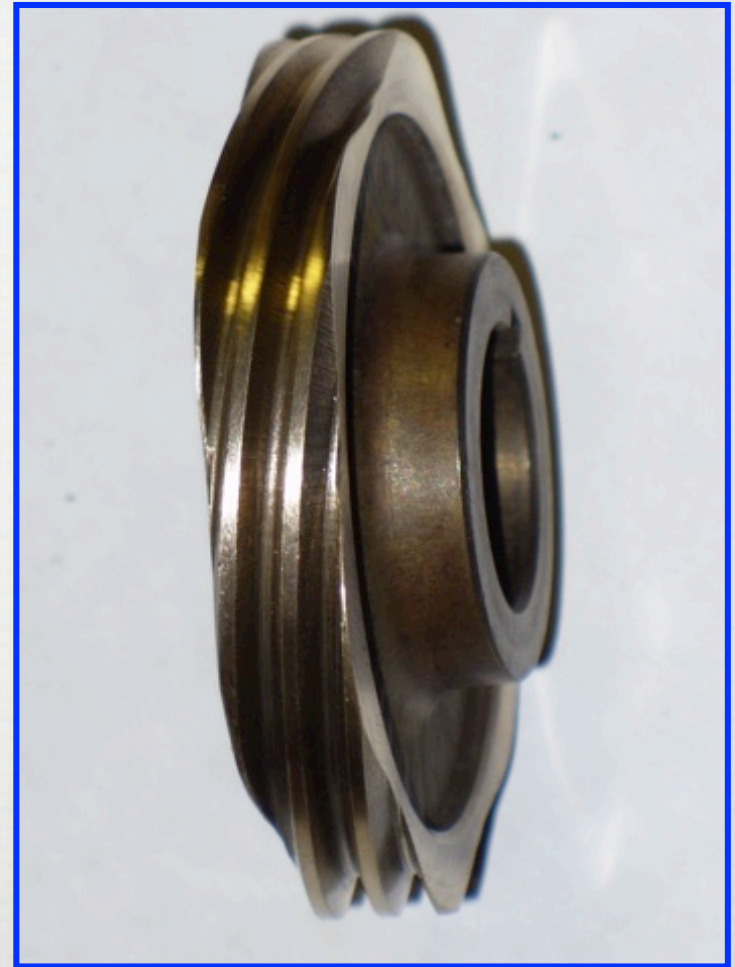
OIL PUMP DRIVE

- ❑ The oil pump and ignition distributor are driven off the crankshaft via a bronze worm wheel.
- ❑ Both driving and driven gears are prone to wear, particularly the bronze wheel which in this location has the effect of retarding the ignition timing over time.
- ❑ To minimize this wear, it is helpful to polish both gears, but particularly the steel oil pump drive gear.
- ❑ I used the nylon brush wheel for this purpose.

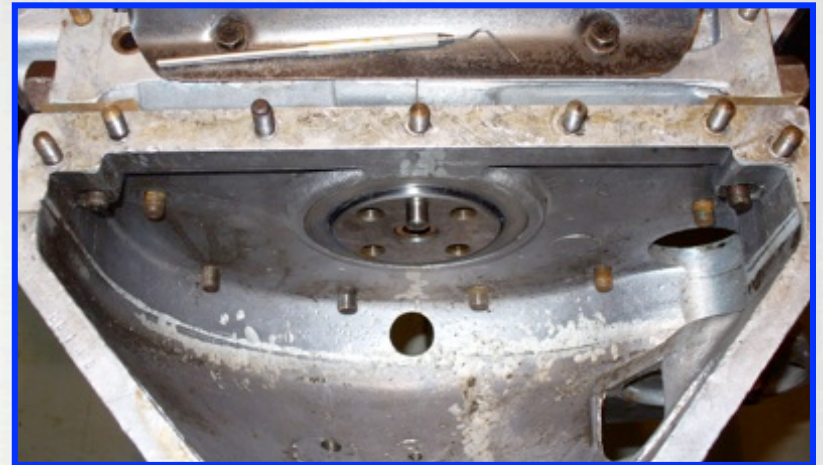
FLYWHEEL RUN-OUT MEASUREMENT

- ❑ The flywheel is retained with four bolts. Use the best ones you can find and use new shakeproof washers and/or thread locking agent. Torque to 60 lb/ft.
- ❑ I checked for flywheel runout in the manner shown here. It was good.
- ❑ This flywheel was slightly thinner than standard so appears to have been mildly lightened.

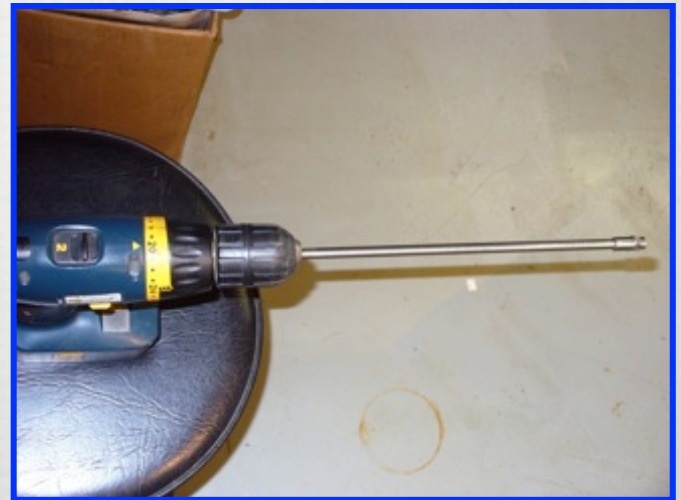
PUSHRODS

- ☐ The pushrods were cleaned up on the abrasive nylon brush wheel.
- ☐ Lacking anything better, they were individually spun in the electric drill to identify if they were bent.
- ☐ The solid tappets had already been cleaned up with the nylon brush wheel and the cam interface surface refinished by lapping.

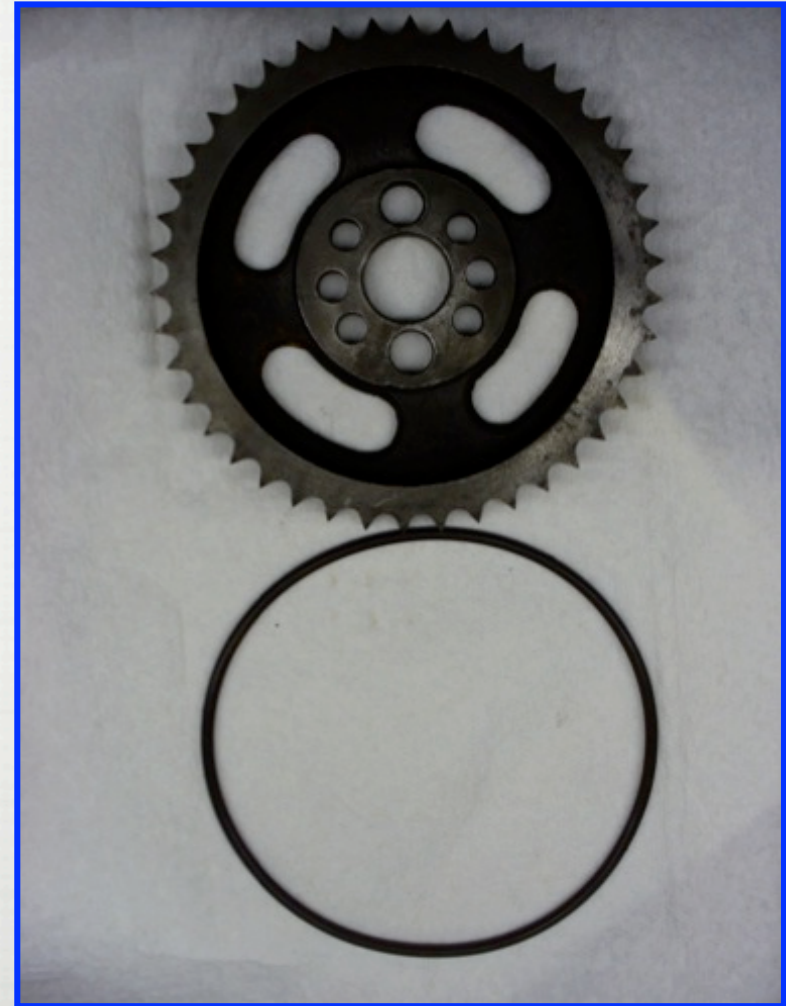
CAMSHAFT CHAIN WHEEL

- This is the normal (later) chainwheel with the vernier holes for cam timing adjustment.
- Normally, there is no provision for taking up timing chain wear, but I added the neoprene o-ring seen here into the central trench between the two sheaves. This is a strategy used by others such as BMC.
- In the next two slides the cam timing is being set per the manual and the dowel has been inserted in the pair of holes that most closely coincide.

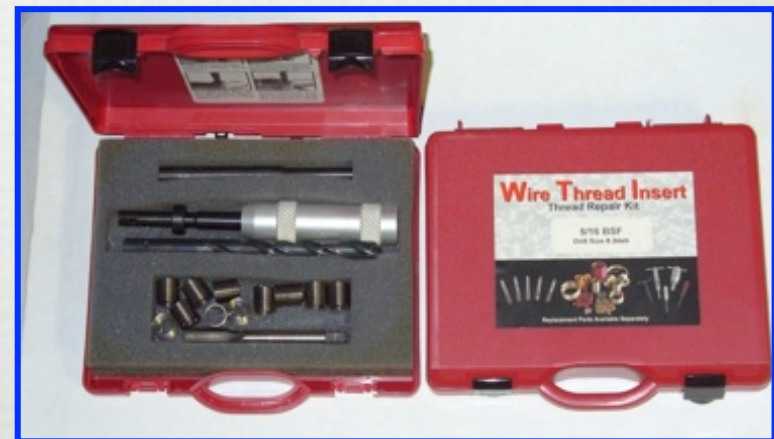
OIL FILTER HOUSING

- The o-ringed adapter plate is only supposed to eliminate leaks from the pressurized oil galleries. A sealant is still required on both sides of the adapter plate except around the o-rings to prevent crankcase oil from seeping out.
- It is still necessary to fit the half-moon felt in the recess at the crest.
- One of the retaining bolt threads in the crankcase had been stripped at some time and required a thread insert, obtained from here: <http://www.wti-fasteners.co.uk/>

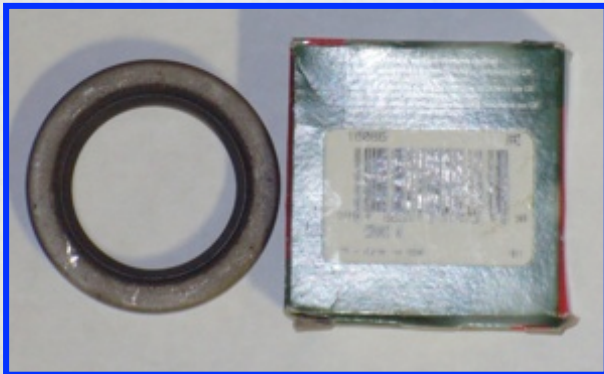
FRONT TIMING COVER

- A new paper gasket was made using a small hammer in the time-honored manner.
- Pressing in the new front crankshaft oil seal requires care to ensure it ends up square. Try to arrange for the lip to engage an unworn section of the pulley seal diameter.

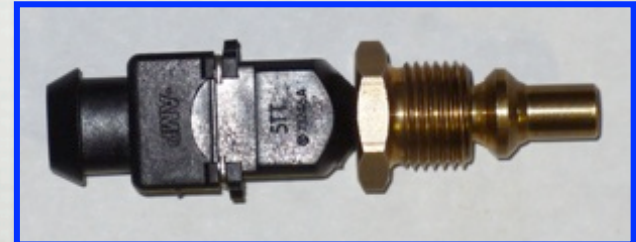
TIMING COVER AND OIL COOLER

- This engine is fitted with a Bowman oil cooler that relies on ram air for heat transfer.
- Oil flow is from the filter to the cooler, and then back to the main oil galleries in the crankcase.
- For those with a broken original capillary-type oil temperature gauge, I discovered that a Lucas electronic sender fits in the same port. —————→

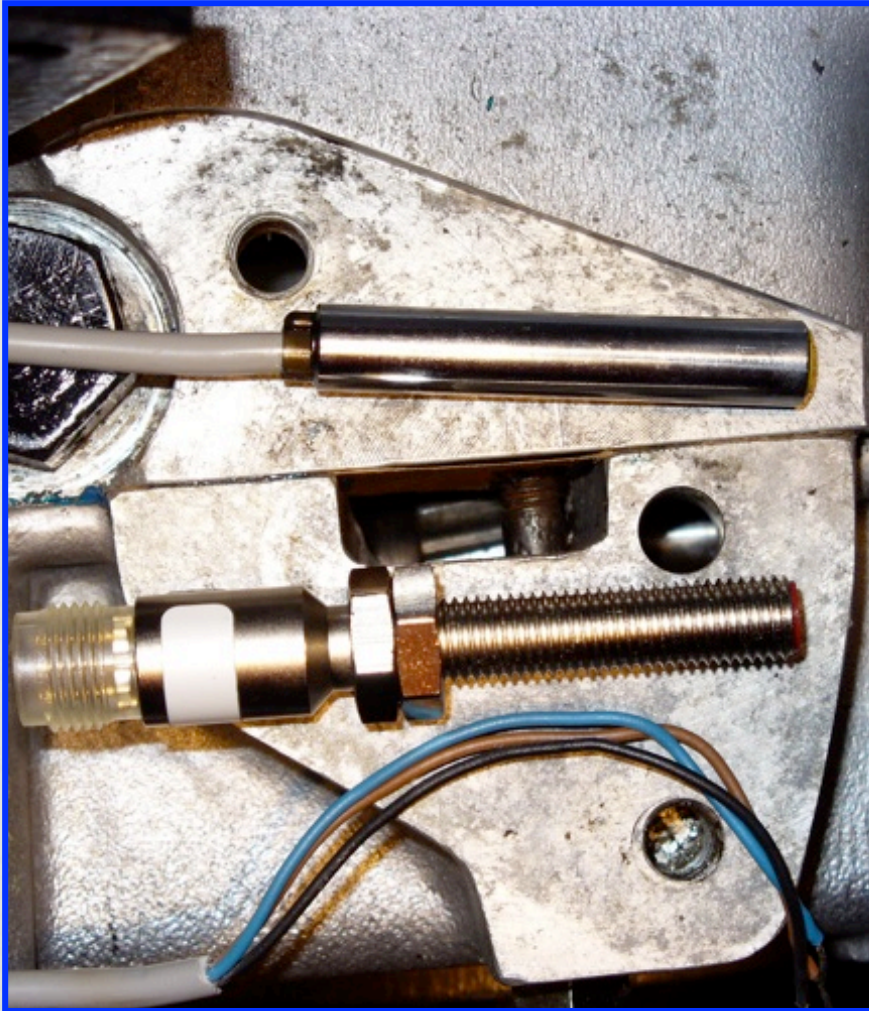
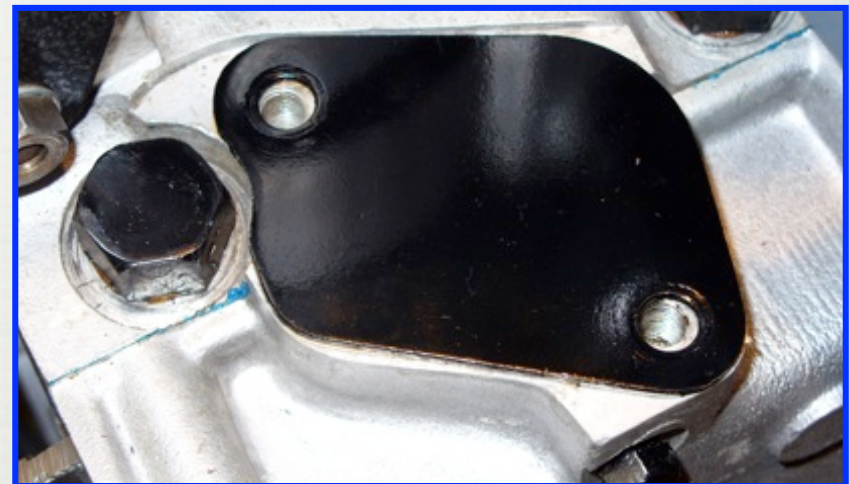
- The petrol pump mounting pad is normally blanked off with a steel plate on the Jupiter because it has an SU electric pump.
- But this view shows that the half-speed drive shaft eccentric is visible and the 12 tooth oil pump drive gear.
- It gave me the idea that these could be used in conjunction with sensors to give engine speed and/or position with an electronic controller.
- Next slide gives an example.

These happen to be industrial sensors not automotive, but you get the idea.

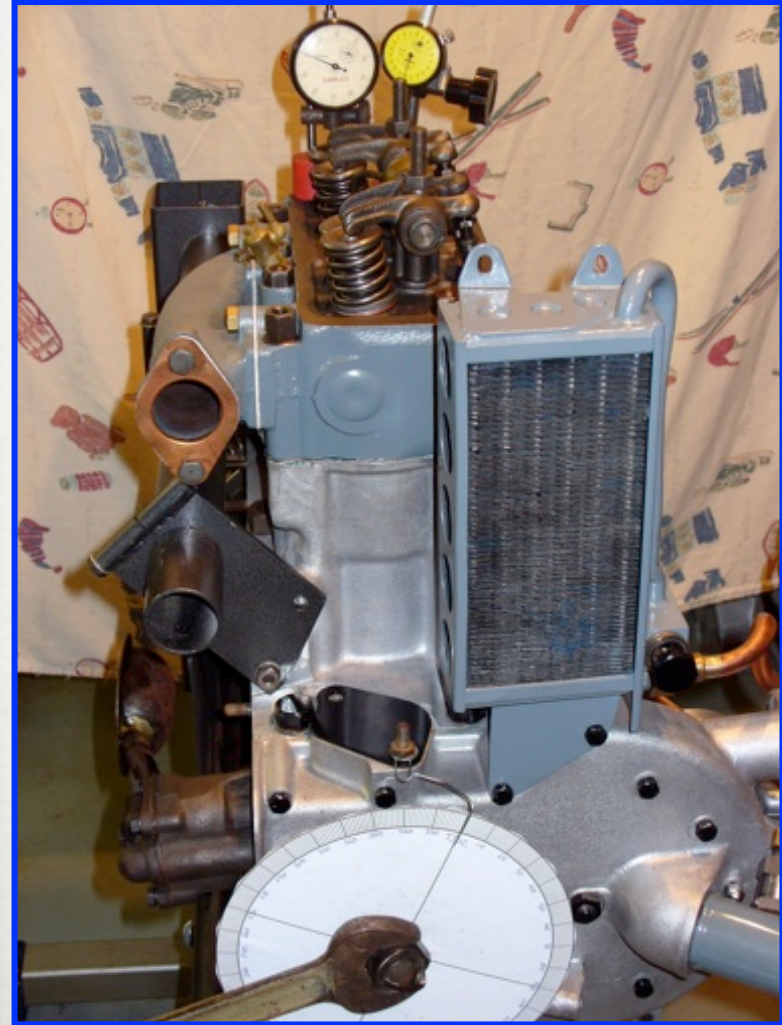
ROCKER SHAFT DEFLECTION

- I discovered that the valve motion was not nearly as smooth as it should have been and that there were obvious deflections taking place.
- As expected, one of the deflections was at the rocker shaft, seen being measured here at full valve lift.
- Far worse was the effect of side-to-side clearance of the camshaft in its bore. Because the camshaft is balanced between the valve spring forces of the opposing cylinders, any slop will allow the camshaft to jump from side to side resulting in very undesirable valve motions. This exercise is reported in detail elsewhere.

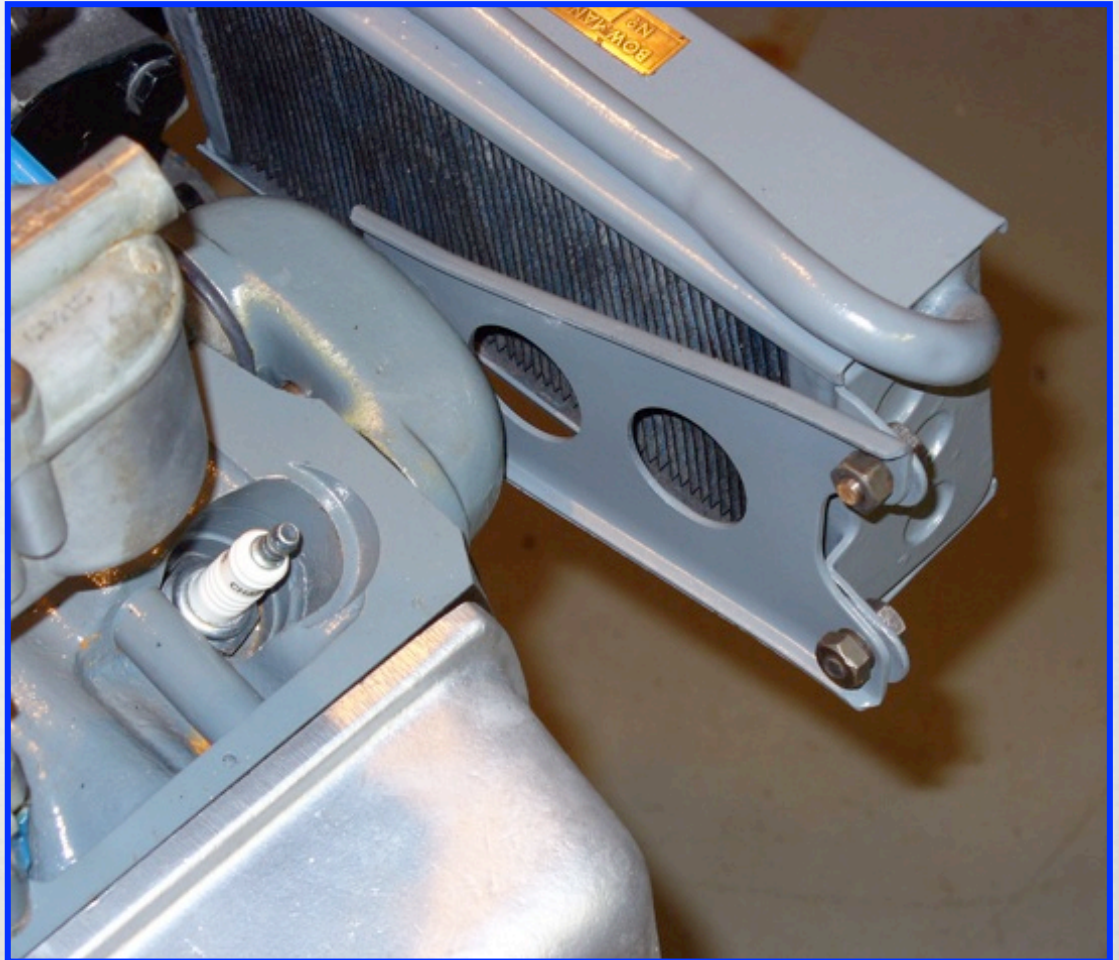
OIL COOLER SUPPORT BRACKET

- With the correct bracket to support the Bowman oil cooler, it makes a reasonably robust assembly from the up-and-down and side-to-side motion of the engine on its mounts. For the fore-and-aft accelerations that are peculiar to the flat-four layout (due to the out-of-balance couple), it is not so good.

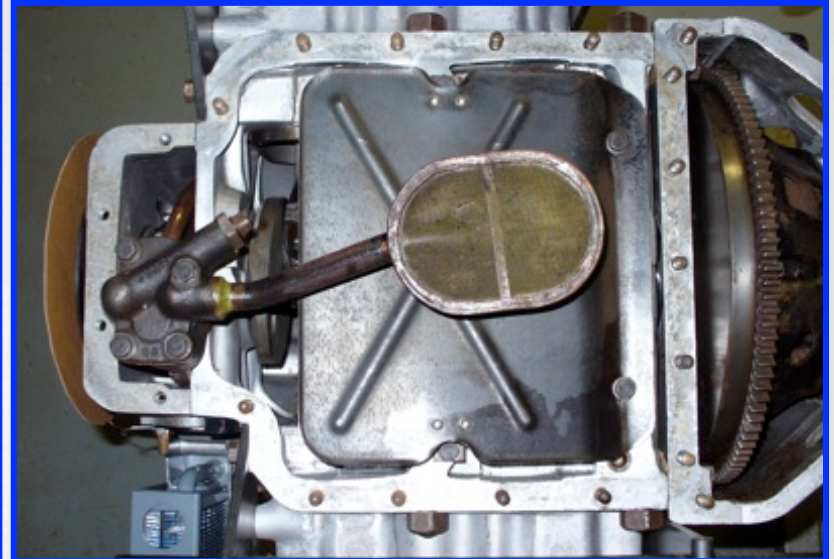
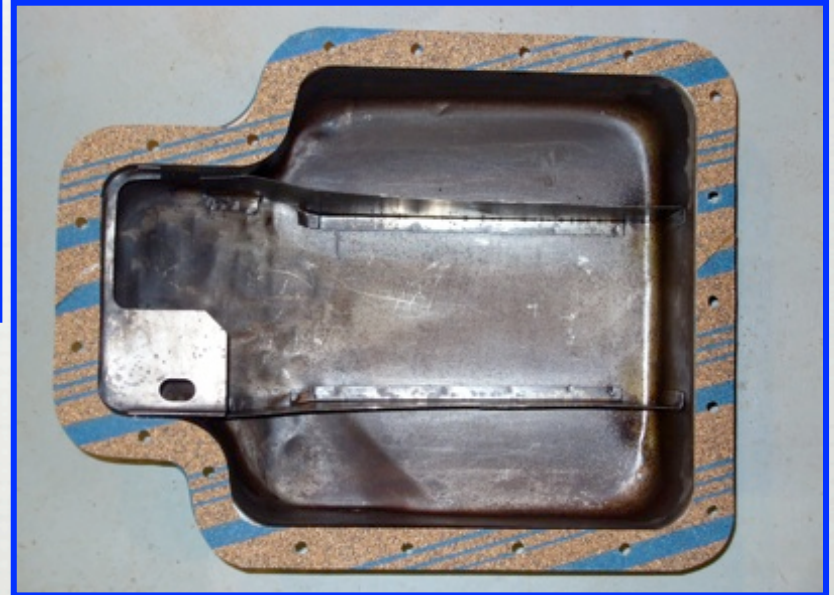
Before installing the oil pan, all bolts are checked for torque and then marked.

A new oil pan gasket was made from rubberized cork.

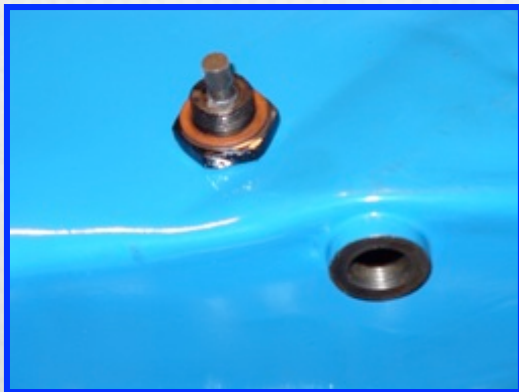
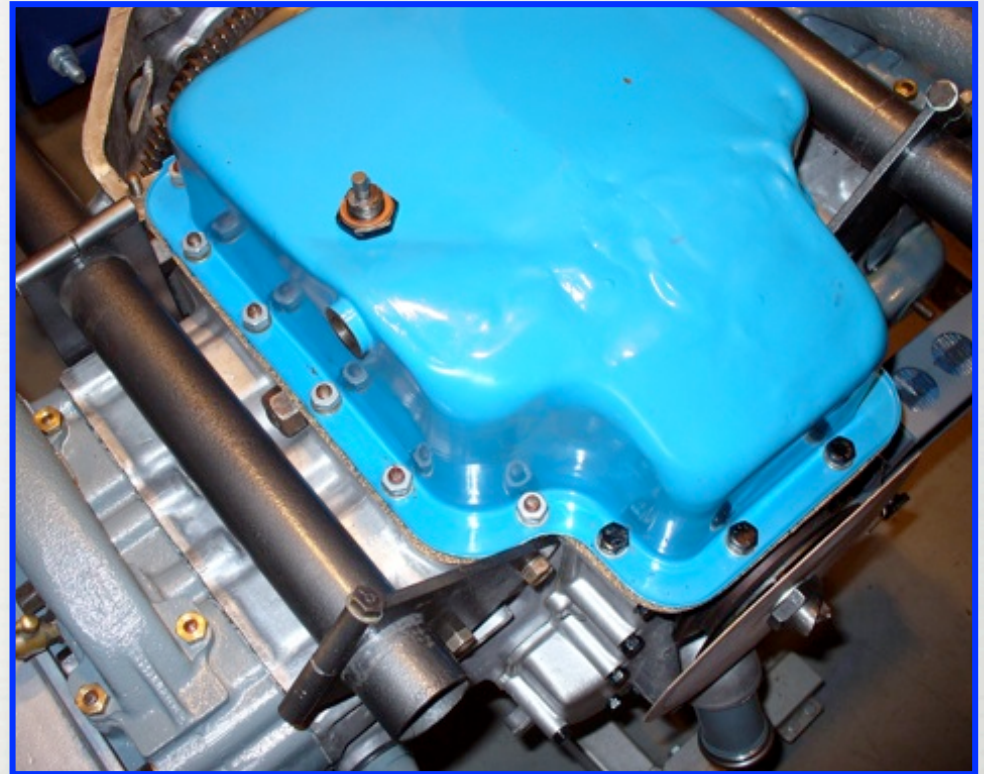
OIL PAN DRAIN PLUG MAGNET

- Adding a magnet to the sump drain plug is a prudent modification.
- Some of the oil pan/sump retaining studs are not blind and break through into the crankcase. Measures must be taken to prevent oil leaking past the threads.

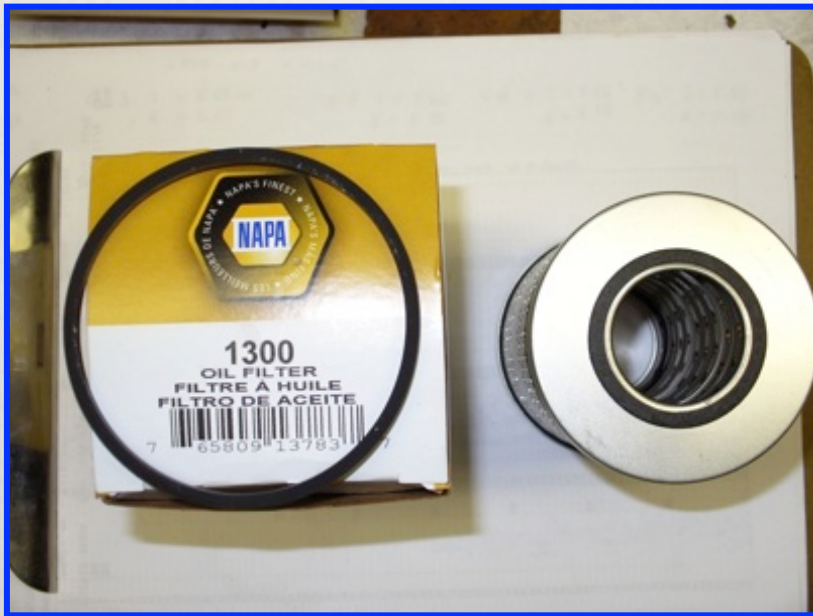
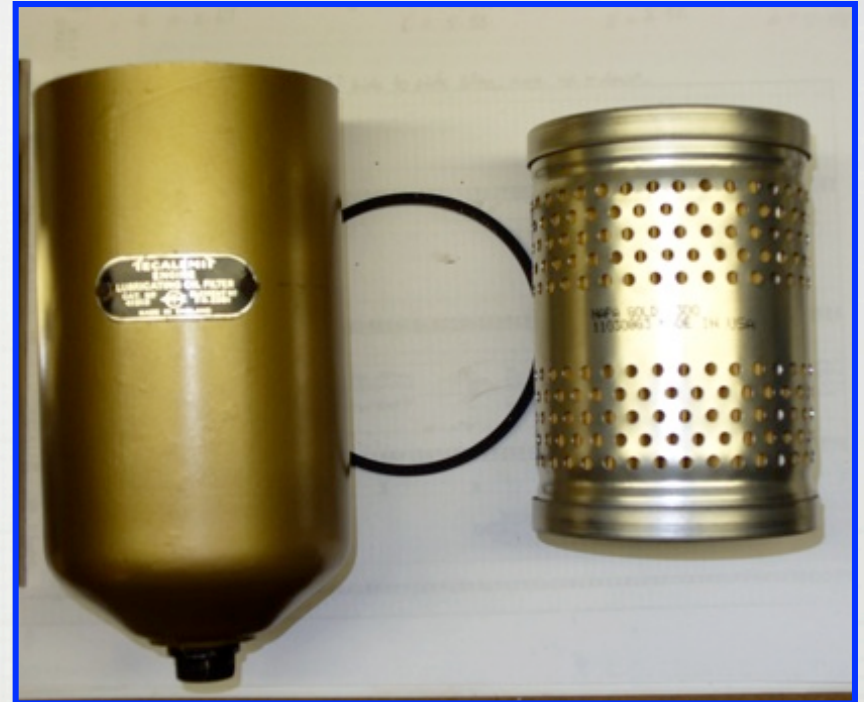
OIL FILTER ELEMENT

- Good quality oil filter elements of the correct size for the Jowett engine are readily available from auto parts stores. This is the type 1300 from NAPA.

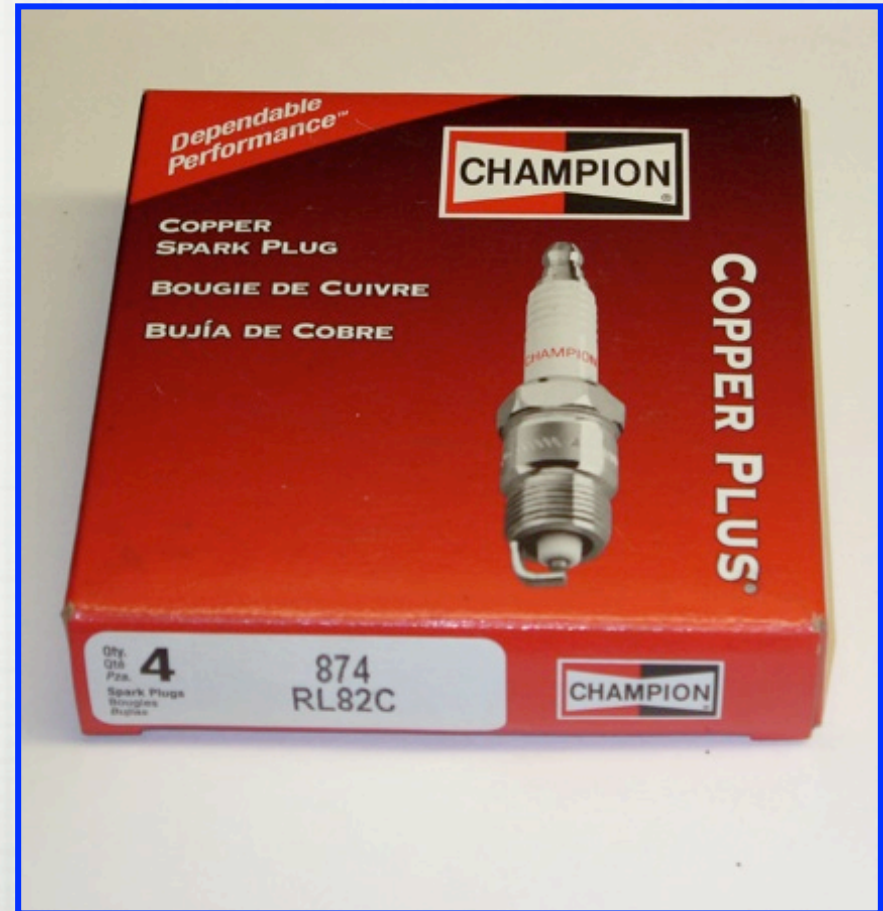
RECOMMENDED SPARK PLUG

- The original specification Champion L10 spark plugs have been superseded, so a modern replacement must be found.
- Consultation with experts at www.sparkplug.com returned the recommendation that Champion **RL82C** is the closest modern replacement, suitable for normal driving, while the NGK **BPR6HIX** iridium tip plug is appropriate for performance motoring.

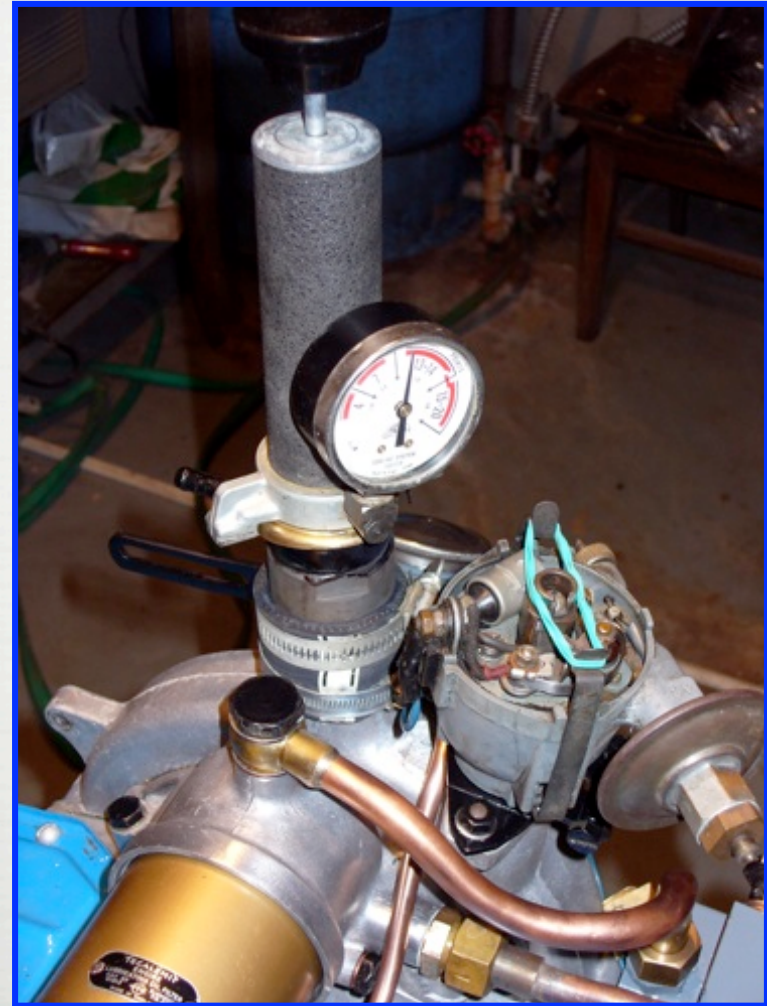
COOLING SYSTEM PRESSURE TEST

- Given the propensity for coolant leaks in odd places with the Jowett engine, it is prudent to perform a cooling system leak check on the assembled engine while it can still be readily worked on.
- I filled the system with water, made up an adapter to fit the pressure tester to the engine, and pressurized it to ~10 psi.
- It turns out, I did have a leak past the head gasket and up a head stud into the rocker box. It was resolved with a more careful application of lead wire under the offending head stud nut.

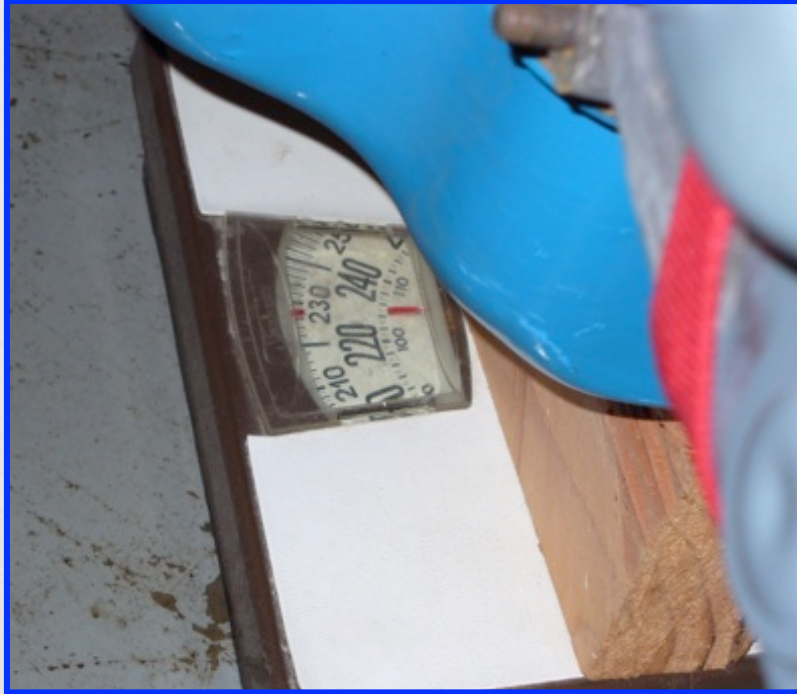
CAPTURING ENGINE WEIGHT

After hoisting the engine out of the stand, I lowered it onto a scale to record its weight. In not fully dressed (no starter, dynamo or water pump) state, it weighed 230 lb (103 kg).

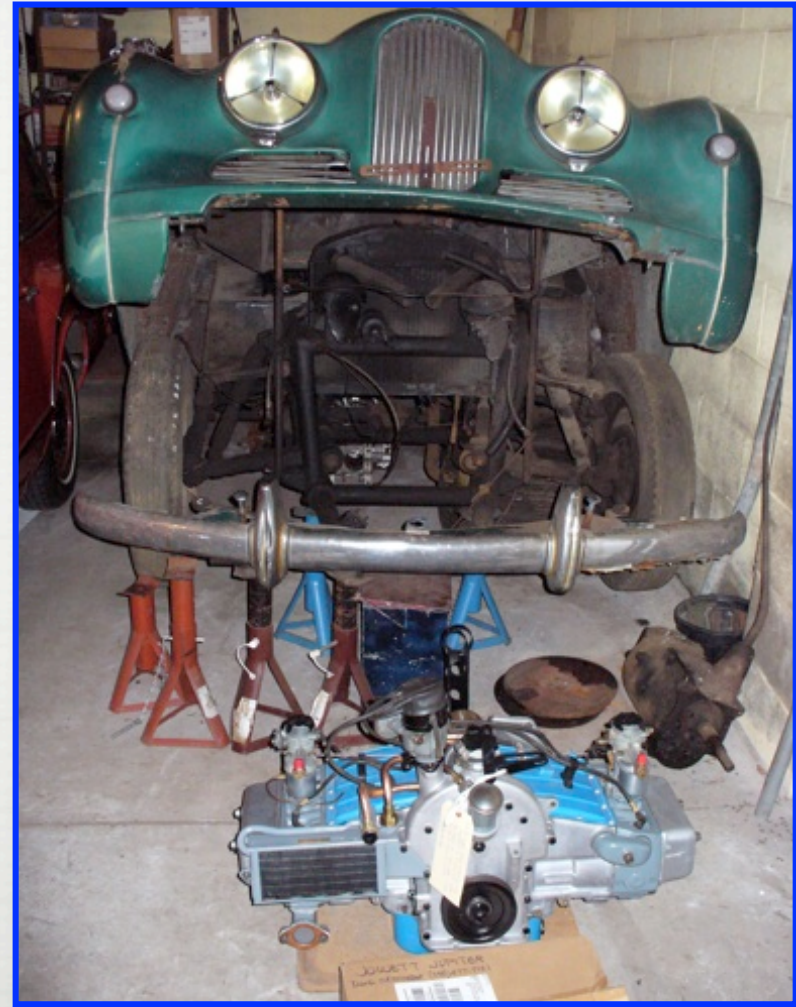
ENGINE DELIVERED

- Here is the engine in the Cleavinger garage in front of his Jupiter. The gearbox to the right of the engine is unrelated to this car.
- From the factory, most painted items on the engine were stove-enameled black. The blue and grey painted items on this engine were provided by David and I think depended on what can of paint was open at the time!
